MAGGIO ESTATE DAM No. 2

NDI No. PA01120
PennDER No. 41-103
Dam Owner: Estate of Michael Maggio

PHASE I INSPECTION REPORT NATIONAL DAM INSPECTION PROGRAM

Maggio Estate Dam No. 2, Lycoming County, Pennsylvania
NDI No. PA 01120, PennDER No. 41-103
Red Run
Inspected 31 March 1981

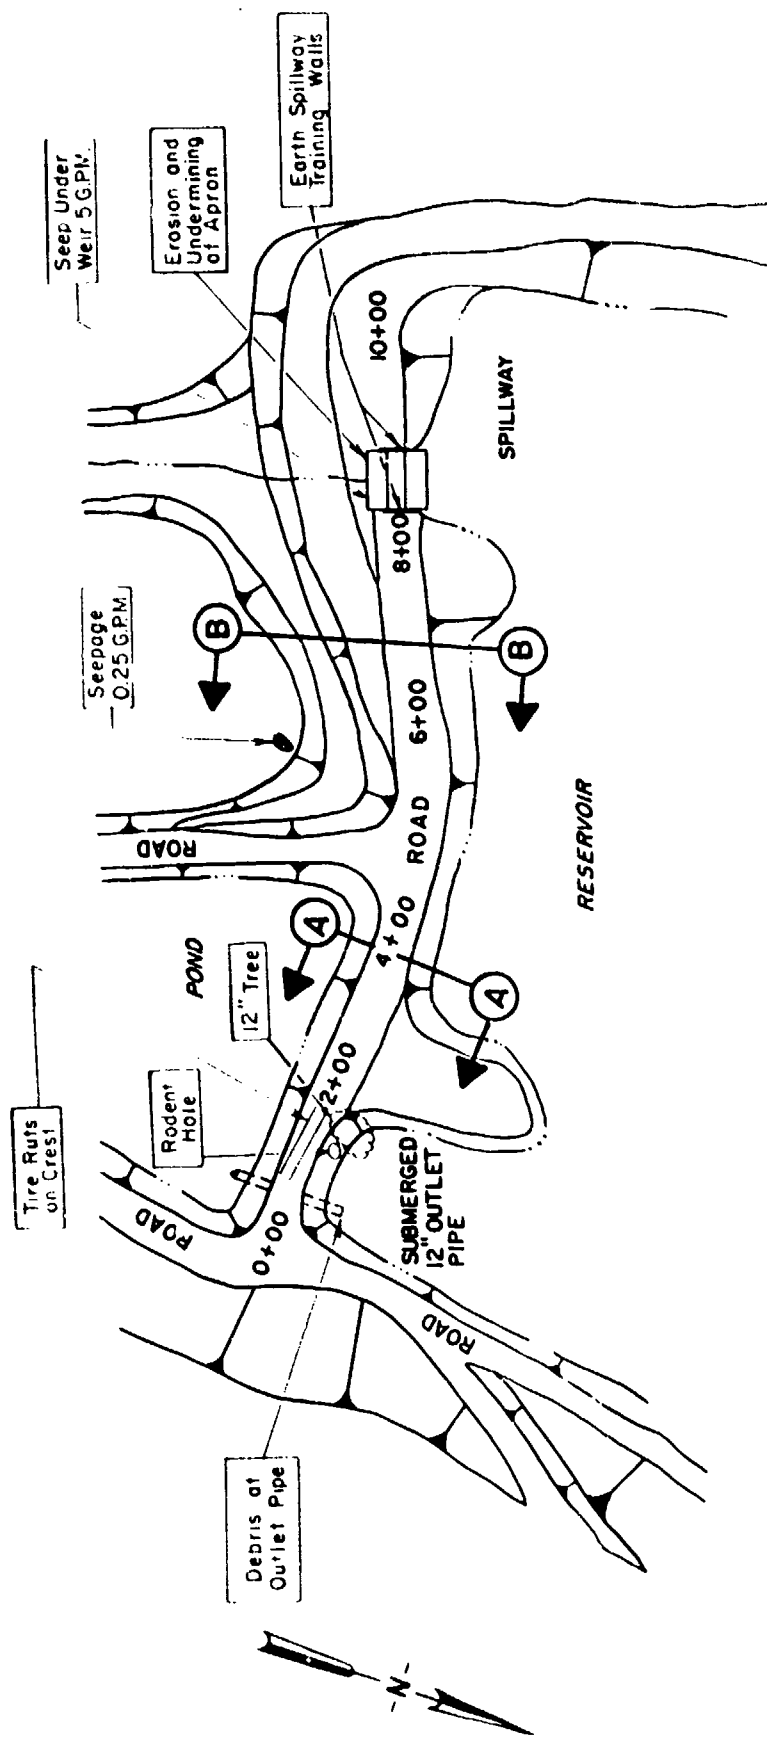
FIELD SKETCH

- b. Embankment - Tire ruts are located on the crest of the left section of the embankment. A rodent hole is located on the upstream face near the left abutment. Low brush and a few small trees are growing on the embankment. About 200 feet left of the spillway at the downstream toe of the embankment, a clear seep of approximately 0.25 g.p.m. was observed.

- c. Appurtenant Structures - The sides of the spillway are earth with no erosion protection. The downstream edge and sides of the concrete spillway are eroded and undermined. A clear seep of approximately 5 g.p.m. was observed at the downstream end of the concrete spillway. The earth discharge channel has very little erosion protection. Debris is collecting near the entrance of the 12-inch concrete outlet pipe.
